Wang, Yu, Wang, Qingsong, Wen, Jennifer X., Sun, Jinhua and Liew, K. M.. (2017) Investigation of thermal breakage and heat transfer in single, insulated and laminated glazing under fire conditions. Applied Thermal Engineering, 125 . pp. 662-672.

Investigation of thermal breakage and heat transfer in single, insulated and laminated glazing under fire conditions

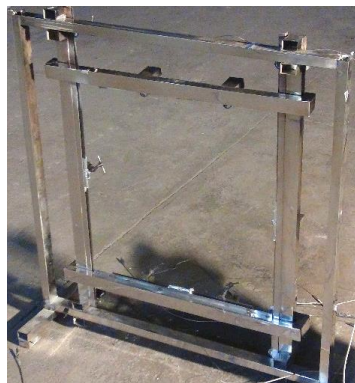
(b) The exposed framing glass.

As shown in Fig. 1(a), the experimental setup primarily consisted of the fire source, framing glazing and instrumentation. A 500×500 mm² pool fire was employed to provide the radiation source. N-heptane with a 99% mass fraction was used as fuel and its mass and distance from the glass pane were adjusted depending on each experimental requirement. It should be noted that a pool fire cannot provide as uniform thermal loading as a radiation panel, but it may model a real fire situation especially the great thermal shock. In addition, its fire load and location can be easily changed to achieve the experimental purpose, as has been proved reasonable in previous work [22]. Fig. 1(b) shows that a well-designed frame made of stainless steel, which can withstand 1200 °C, was used to support the glass pane: in the thickness direction, the glass pane was clamped using several thin strips, and the clamping pressure could be controlled by revolving screws. The width of the covered region at the edge was 20 mm. This design ensured that different types of glazing could be well installed and restrained under almost identical conduction, which helps to satisfy the comparison purpose. In the aspect of inducing a thermal gradient, this framing design and real framing have a similar influence on the glazing pane, so the substantial characteristic is considered identical. Tests were conducted for: 1) single coated float glazing, 2) insulated glazing consisting of two clear float glass panes separated by a 6 mm thick air-filled space, and 3) laminated glazing

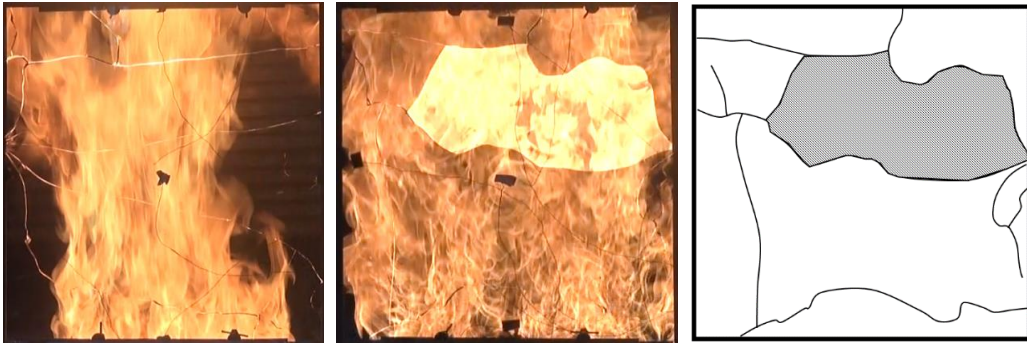
(a) Crack and fallout of single coated glass pane in Tests 1 and 2

Fig. 2. The crack and fallout of glass (viewed from the ambient side).

Figure 2 shows the final post-crack path of the single coated, insulated and laminated glasses. After crack initiation, the crack propagated to the center of the glass pane, bifurcating and crossing. Then, islands formed, resulting in pieces of glass falling out. In a compartment fire, because of the influence of smoke movement and pressure variance, fallout is more likely to occur. However, among the ten tests conducted in an open space, fallout only occurred in Test 2 as shown in Fig. 2(a). The fallout occurred as soon as the first crack was initiated, with a proportion of 20%. It appears that single glazing is more prone to fallout than double-glazed units. However, for the laminated glass, gases such as water vapor, carbon dioxide and hydrogen chloride [33] were emitted from the interlayer when its temperature reached approximately 200 °C. Thus, a large number of bubbles appeared in the interlayer after heating, especially along the crack path where more heat may go through, as shown in Fig. 2(c). More bubbles appeared in Test 10 because of the
